Evaluation of Semi-Permanent Canal Partition Design with Overflow in Aceh Province

ABSTRACT

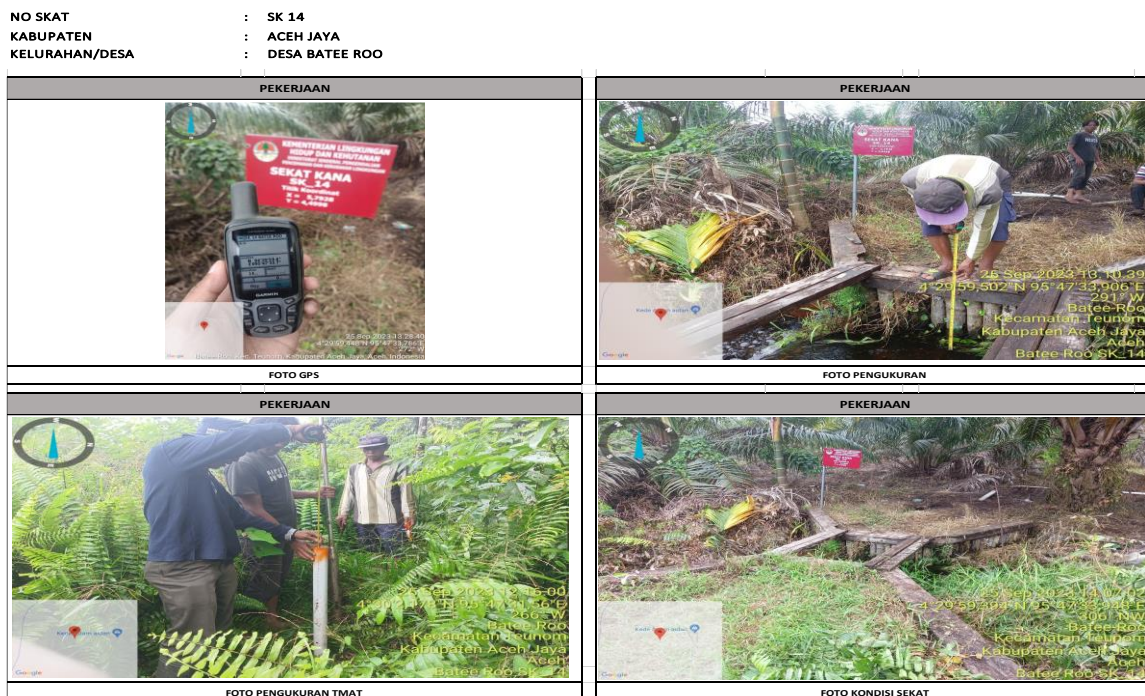
Figure 4a: Condition of canal blocks in Aceh Jaya district

Based on field data collection, the constructed canal blocks are still in a slightly damaged condition. The construction utilized high-quality materials in terms of strength and followed appropriate canal block construction methods. However, there were issues such as subsidence of the canal block's wing sections and non-functional water flow during dry channel conditions. This is primarily due to the use of peat soil to fill the canal blocks and errors in the location placement of the canal blocks. Canal block construction should follow the Director General of PPKL Regulation Number: 11 of 2020 regarding the Guidelines for Rewetting Infrastructure Development. The placement of canal blocks is highly accurate, based on the results of the SID planning study conducted by the Directorate of Peatland Ecosystem Damage Control - Ditjen PPKL in that year.

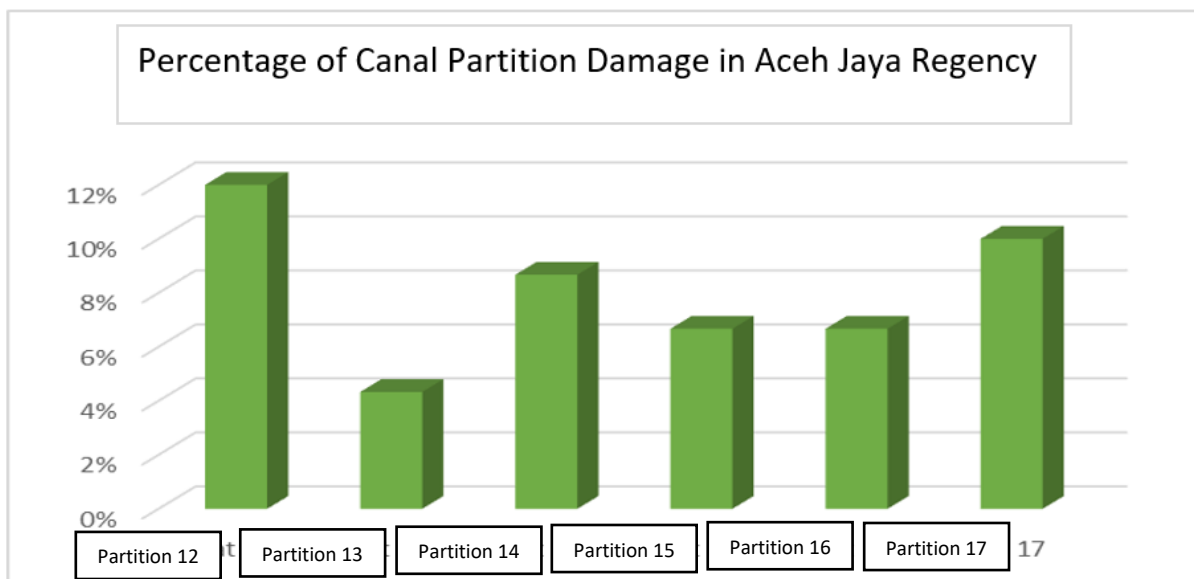
Graph 1. Percentage of Canal Block Damage in Aceh Jaya District

Graph 1 indicates that the highest damage was found in block 12 (12%), while the least damage was in block 16 (6.67%). The data analysis and visual observation show that the canal blocks in Aceh Jaya District are in excellent condition and functioning well.

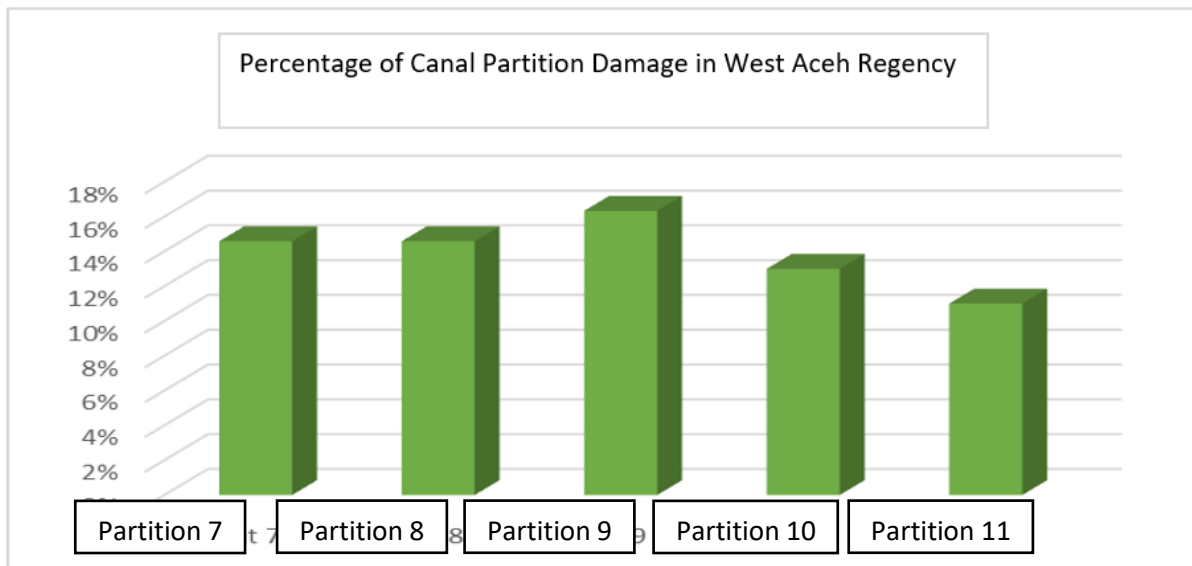
Graph 2. Percentage of Canal Block Damage in West Aceh District

Graph 2 indicates that the highest damage was found in block 9 (16.33%), while the least damage was in block 11 (11%). The damage in block 9 was due to subsidence, measured by the height difference between the top of the canal block and the ground surface using a leveling method. Additionally, the canal block damage was caused by the material decaying due to frequent flooding.

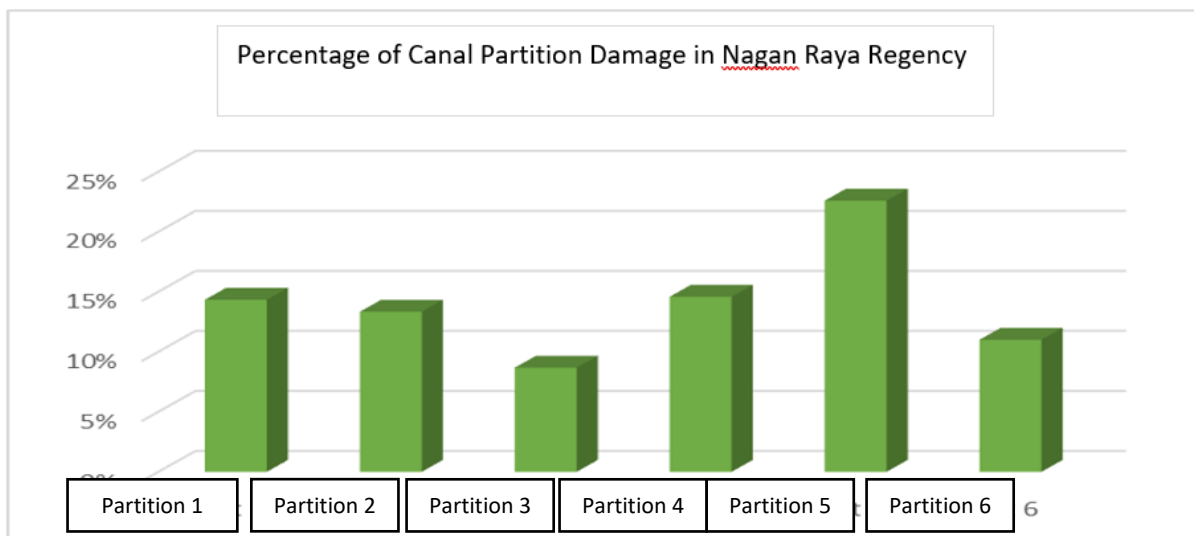
Graph 3. Percentage of Canal Block Damage in Nagan Raya District

Graph 3 indicates that the highest damage was found in block 5 (22.58%), while the least damage was in block 3 (8.67%). The damage in the canal blocks was due to the stability of the construction and hydraulic conditions. Therefore, additional canal blocks are needed for block 5. The observed hydraulic conditions in Nagan Raya included local scouring and high dropping.

The recommendations based on the evaluation of the condition and functionality of the 17 canal blocks include preventive maintenance such as repairing the stakes and boards of the canal blocks, adding mineral soil on both sides of the wings, and maintaining the spillways. Table 5 shows the maintenance recommendations for canal blocks based on the evaluation results in Aceh Province.
